Town of Glenville

ADA Transition Plan

Adopted 7/21/2021
Issued 08/25/2021

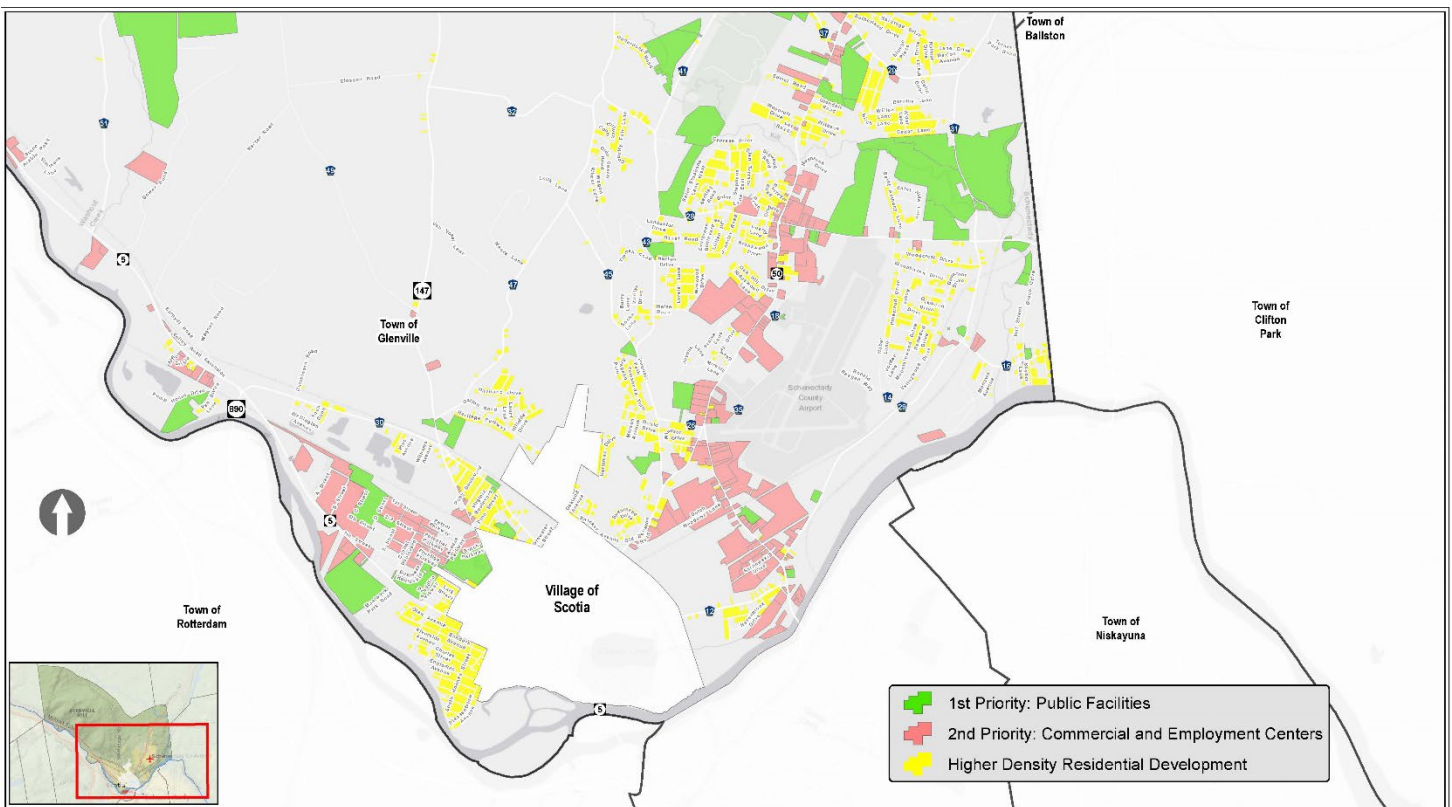
Location Priority Map:

According to the proposed ADA design guidelines, “the U.S. Department of Justice (DOJ) regulation imposes a specific construction requirement...specifies a priority for locating (curb ramps) at State and local government offices and facilities; transportation; places of public accommodation; places of employment; and other locations.” Following this guidance, the Town of Glenville identified its location priority as follows, beginning with the highest location priority:

1. Facilities serving government facilities (including schools);
2. Facilities serving commercial and employment centers;
3. Facilities serving dense residential areas; and
4. Facilities serving other areas

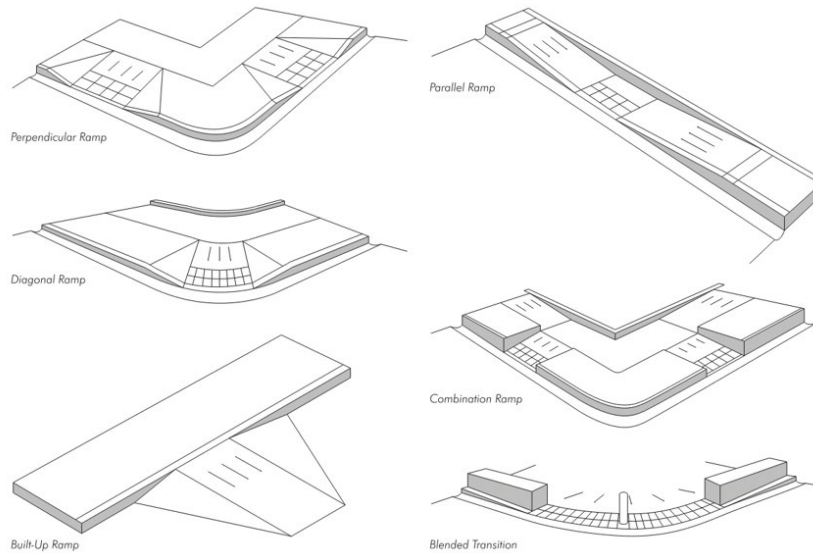
CURB RAMP PRESENT

There are many different types of curb ramps that can be used for different intersection types

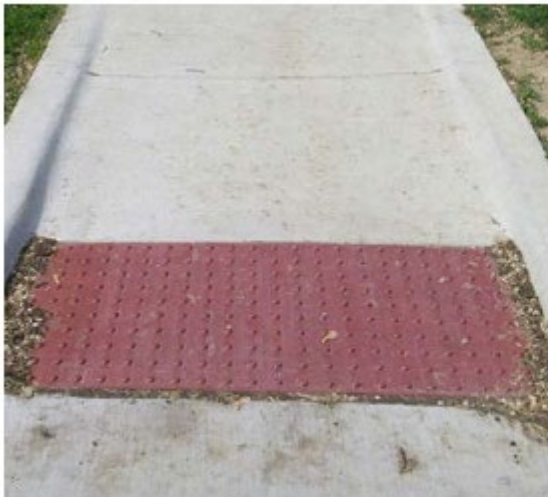
Truncated domes

Truncated Domes: Bubble like domes appear popped out of the DWS. They should have a height of around 0.2 inches. The domes should be aligned in the direction of pedestrian travel.

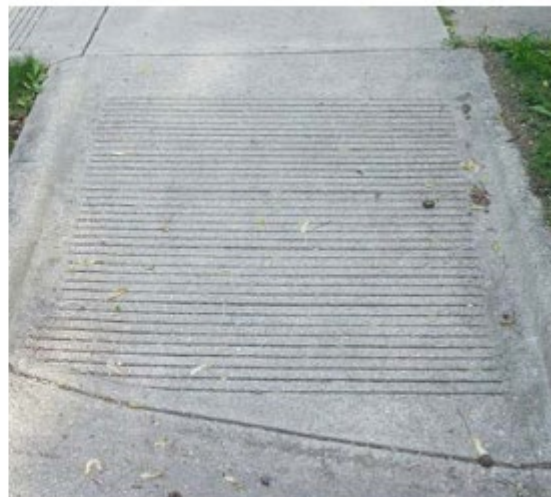
Pavement grooves

Pavement Grooves: Grooves cut into the existing concrete, not an ideal DWS. The grooves should be aligned in the direction of travel.

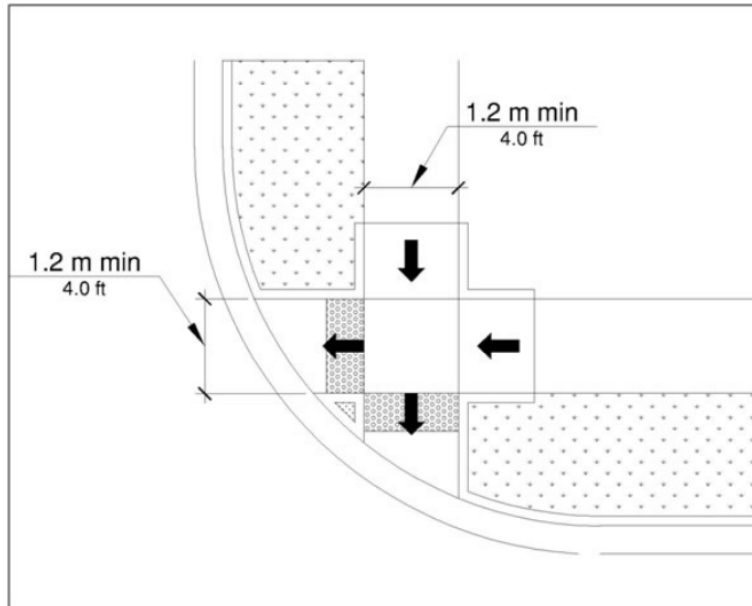
Width: The DWS should extend the full width of the curb ramp or landing space. The minimum width is 4 feet (48 inches).

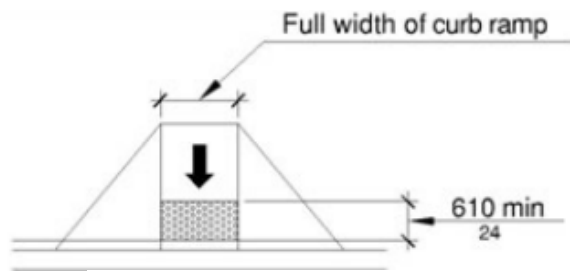
Depth: The DWS should be a minimum of 2 feet (24 inches) in depth in the direction of travel.

(a) perpendicular curb ramp with flared edges

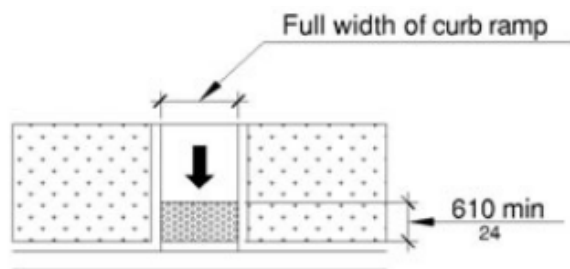
(b) perpendicular curb ramp with returned edges

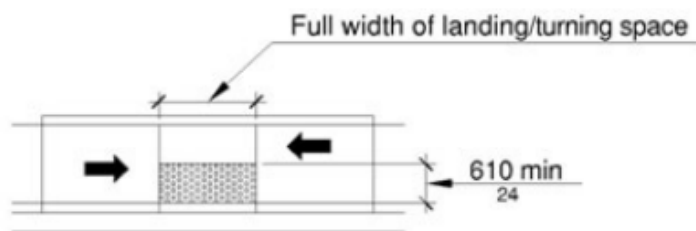
(c) parallel curb ramp

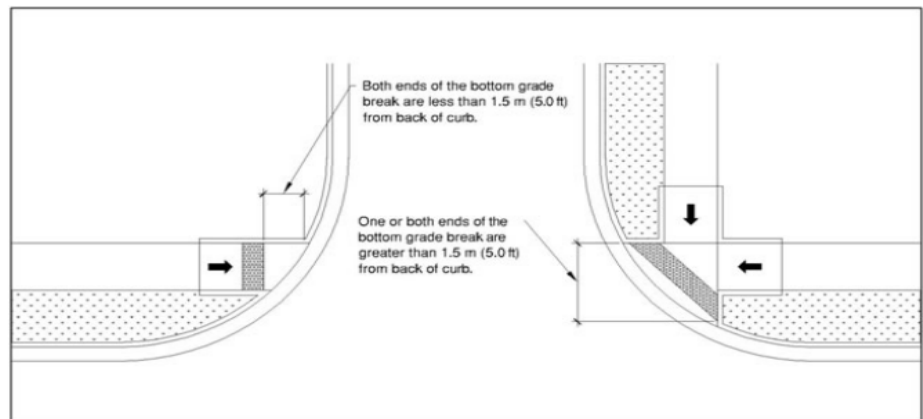
Perpendicular curb ramp

Placement: The DWS should be aligned perpendicular to the pedestrian direction of travel. This depends on the type of curb ramp. Follow the figures below for the appropriate curb ramp.

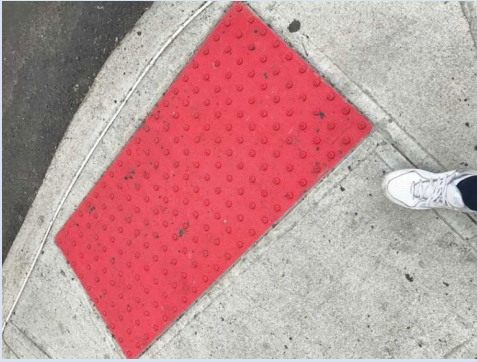
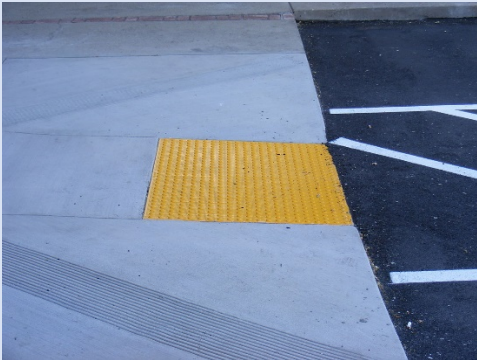
DWS Color Contrasts from Curb Ramp

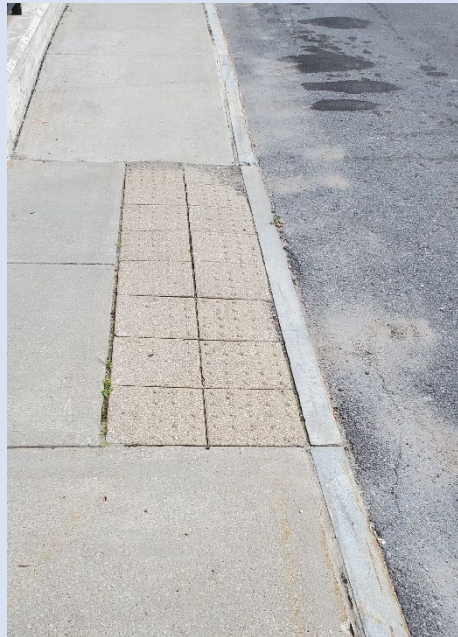
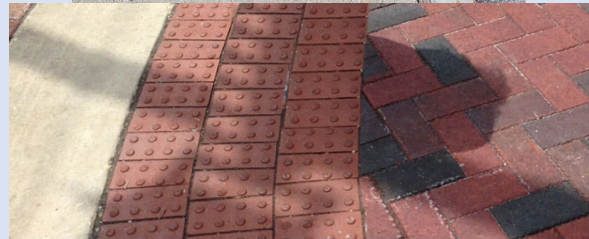
DWS Color Does NOT Contrast from Curb Ramp

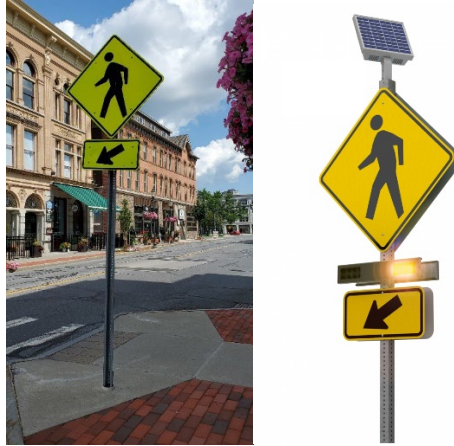
Pedestrian Sign – Not pedestrian activated: A sign marked for pedestrian crossing is used. No button mechanism is used. It may or may not have a flashing feature on it.

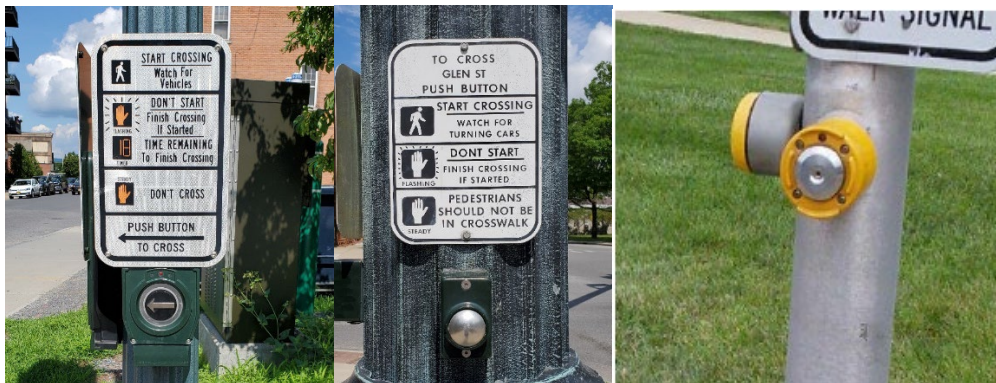
Pedestrian Signal – Pedestrian activated: A button can be pushed by the pedestrian, it then activates a crossing. It may or may not have a flashing feature on it.

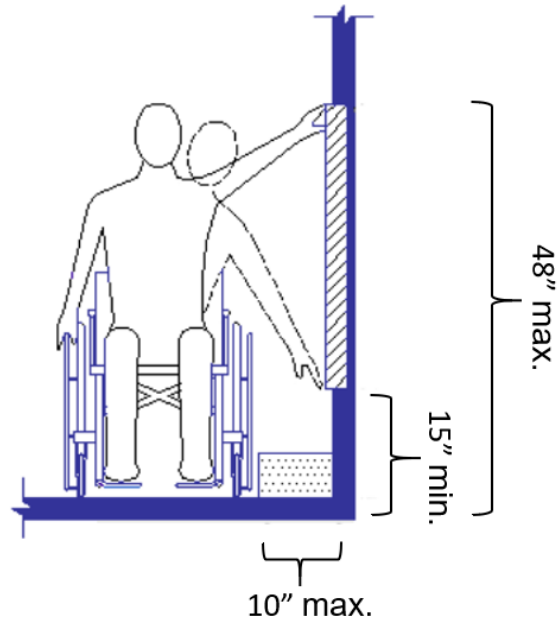
Accessible Pedestrian Pushbuttons

If the pedestrian signal has a button, the button should be mounted within 15 inches to 48 inches above the ground. The button should be accessible with a maximum of a 10 inches side reach.

- ☐ 48" max. above the ground
- ☐ 15" min. above the ground
- ☐ Side reach within 10"

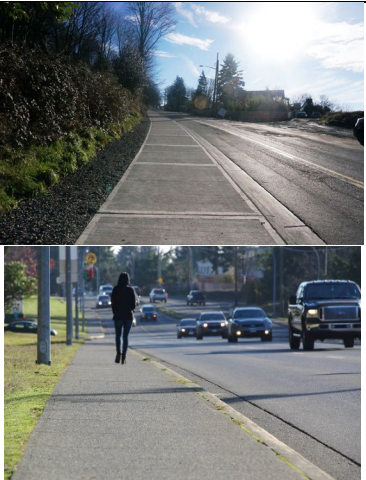
Rating	Condition	Reference Images
Fully Accessible	Sidewalk is new or in like-new condition. Sidewalk is level, no cracks, no faults, no obstructions, and adequate width. Sidewalk is at least 4 feet (48") wide.

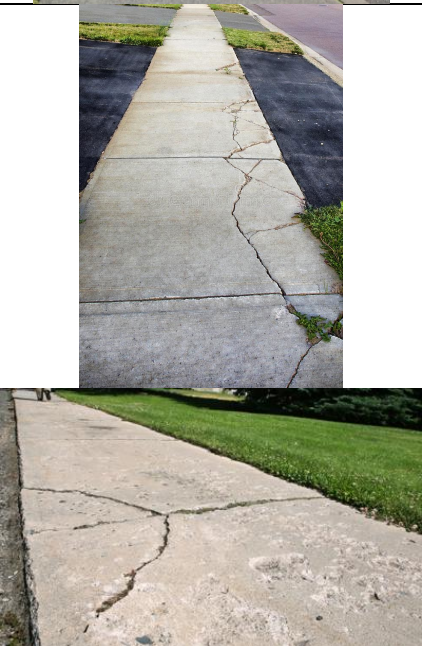
Mostly Accessible	Sidewalk is almost in a new condition. Sidewalk should be level, and width adequate width. Sidewalk may have minor cracks.

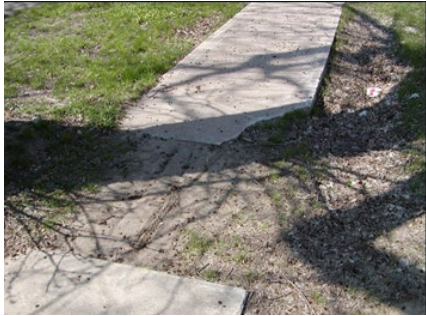
Missing Panels

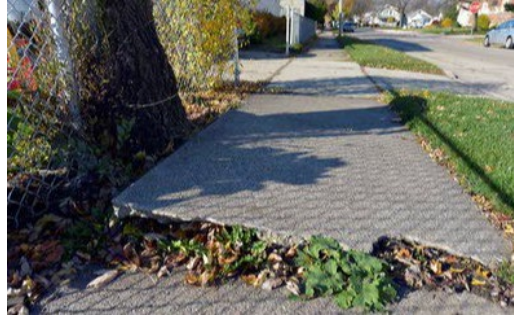
Heaving Panels

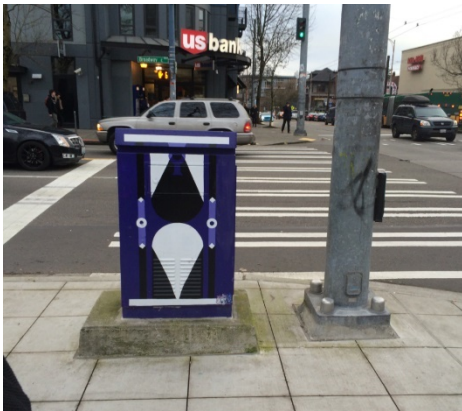
Obstructions

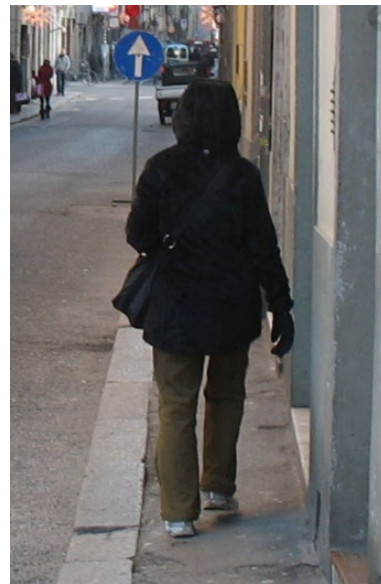
Too Narrow

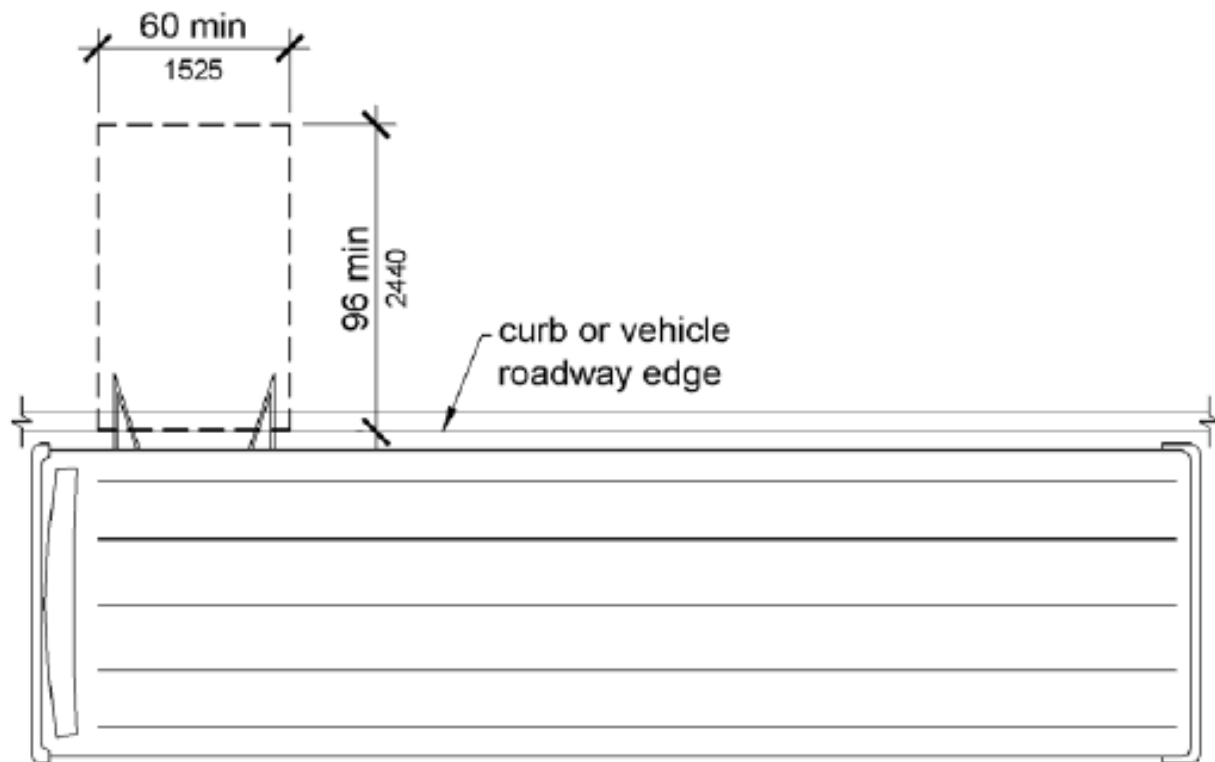
TRANSIT STOPS

Accessible transit stops require a 60" (5') wide landing area and a 96" (8') deep landing zone.
